**Flood Control Project Maintenance
Levee Inspections**
LMA District Cover Sheet
Spring 2017 Levee Inspection Results

Reclamation District No. 1660 Tisdale

Levee Inspection Report By Mile - Spring 2017

Waterway	Bank	Unit Miles	Inspection Start/End	Inspector
Unit No. 01 Sacramento River	Left	2.94	04/06/2017 04/06/2017	Bob Duffey

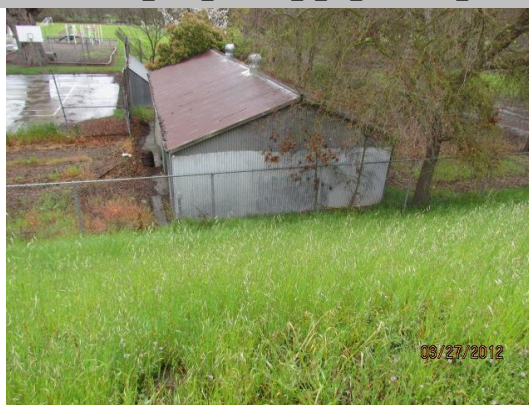
Photo 1 of 1 : SP_2017_RD1660_8_12_20170315_00006.jpg

LM Start	0.05	Rating **	M	Issue No.	12
LM End	0.05	Issue Type +	En	Location *	LS
Category	Earthen Levee			GPS Latitude/Longitude	
				Start	End
Item	Encroachments			39.062643 °	39.062643 °
				-121.837857 °	-121.837857 °
DWR ID	DWR_RD1660_01_s_2012_12				
Comment Code					
BU : Building					
Inspector Comment

View of the building and fence at the landside toe.

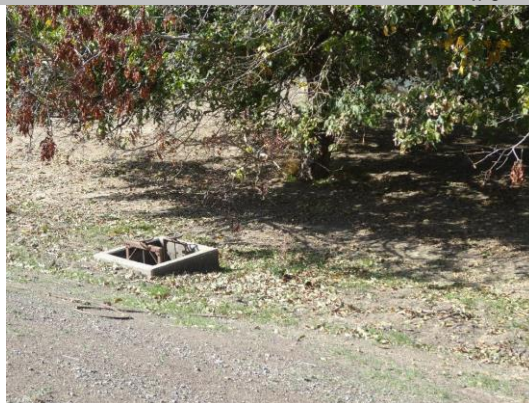
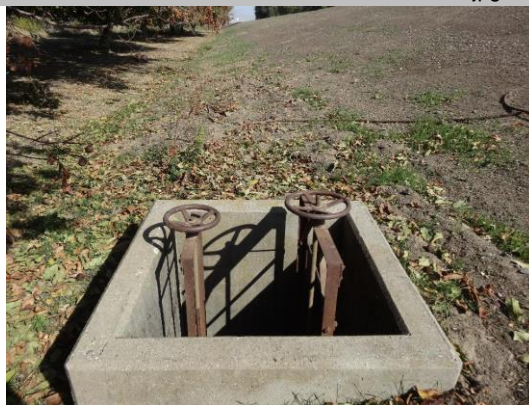
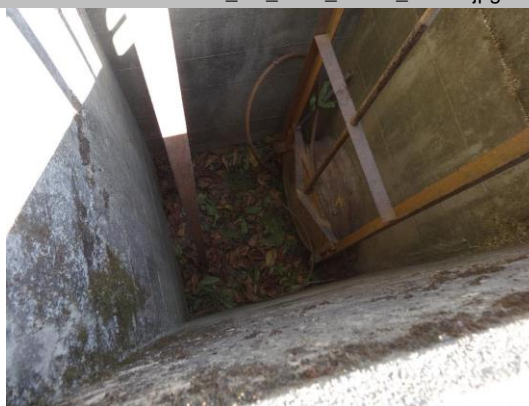
LM Start	0.14	Rating **	M	Issue No.	21
LM End	0.14	Issue Type +	Ma	Location *	LS
Category	Supplemental			GPS Latitude/Longitude	
				Start	End
Item	DWR UCIP LMA Responsibility			39.061322 °	39.061322 °
				-121.837993 °	-121.837993 °
DWR ID					
Comment Code					
Inspector Comment					
FS_ID:46670					
DS_ID:22489					
EP_NO: N/A					
Repair Type: Non-Urgent					
Crossing Status: Found					
UCIP Comments: - needs proper abandonment.- opening of landside pipe almost buried.					
FIELD_STRUCT_DESC: *ABANDONED* 24-inch pipe thru levee, 16.4					
FBC. Slide gate in concrete well at toe of WW slope. (IV A-Winship).					
USACE bench mark on top of headwall at LS toe. O&M Manual SAC					
133, August 1955.					
FS Date: 10/10/2013

WS view: concrete box on levee slope. No pipe found on berm and river bank.

WS view: two slide gates in concrete box on levee slope.

WS view: closer view of two slide gates in concrete box on levee slope.

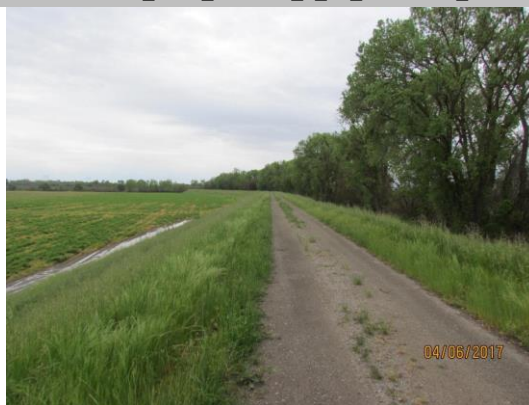
Photo 1 of 1 : SP_2017_RD1660_8_19_20170410_00017.jpg

LM Start	0.61	Rating **	A	Issue No.	19
LM End	0.61	Issue Type +	Ma	Location *	LS
Category	Earthen Levee			GPS Latitude/Longitude	
				Start	End
Item	Vegetation			39.054537 °	39.054537 °
				-121.839288 °	-121.839288 °
DWR ID	DWR_RD1660_01_s_2017_19				
Comment Code					
V1 : Control annual grass and weeds on the levee slopes and easements.					
Inspector Comment					
There are native grasses on both slopes.

View of the native grasses on both slopes.

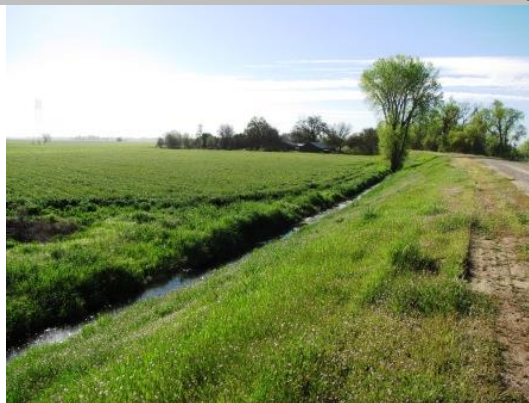
Photo 1 of 1 : SP_2017_RD1660_8_9_20170315_00005.jpg

View of a ditch along the landside toe.

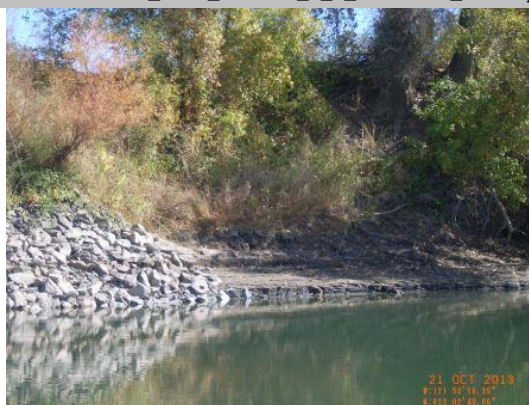
Photo 1 of 1 : SP_2017_RD1660_8_8_20170315_00004.jpg

LM Start	1.33	Rating **	M	Issue No.	8
LM End	1.36	Issue Type +	Ma	Location *	WS
Category	Supplemental			GPS Latitude/Longitude	
				Start	End
Item	2015 USACE Erosion Survey, DRAFT			39.044361 °	39.043916 °
				-121.837654 °	-121.837305 °
DWR ID	DWR_RD1660_01_s_2016_8				
Comment Code					
Inspector Comment					
2009 - Erosion on levee toe where an old cobble site is failing. 2011 - Some new minor erosion. 2012 - Site extended downstream, bank is being impacted from the weight of the trees. 2013 - Minor new erosion at the toe. 2015: Minor new erosion at the toe. [2015 Site ID: SAC_120-6_L]

USACE 2013 Photo #1

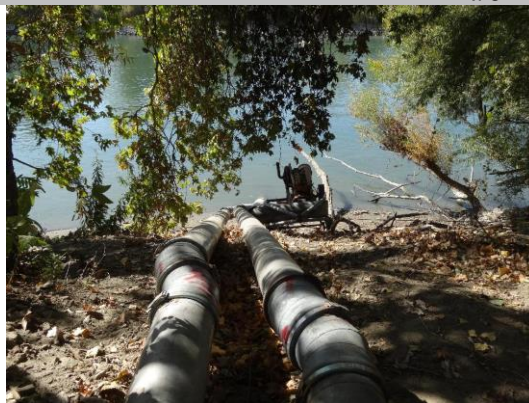
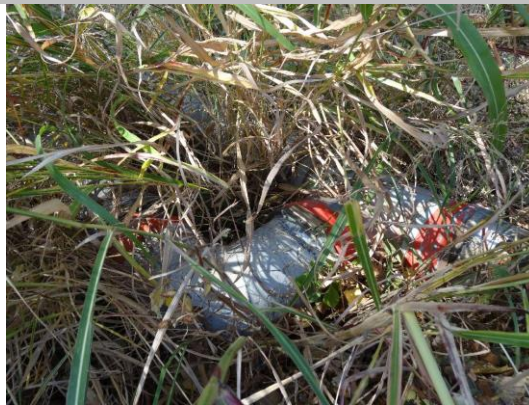
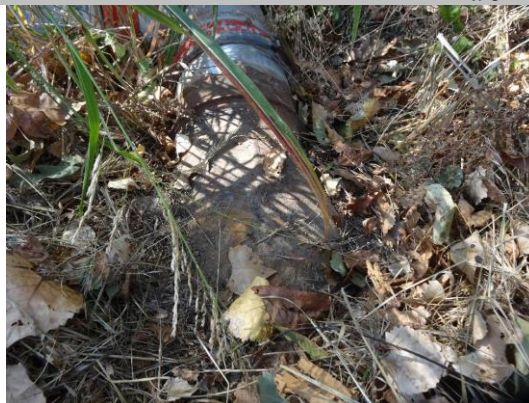
Comment Code					
Inspector Comment					
FS_ID:22543 DS_ID:22484 EP_NO: 16476 Repair Type: Non-Urgent Crossing Status: Found UCIP Comments: - 16-inch old steel pipe abandoned. Abandoned pipe found on landside levee toe.- abandoned power pole on waterside.- mobile diesel pump on channel bank.- attached tin pipes exposed on levee surface. FIELD_STRUCT_DESC: 14-inch steel pipe through the levee crown, the placement of two 12-inch diameter tin pipes on the surface of the levee slopes attached to the existing 14-inch steel pipe. The pipe discharges into irrigation ditch on landside. An air vent on landside shoulder. (App. No. 16476 - Ettl, 1997). FS Date: 10/10/2013

WS view: two exposed 12" tin pipes on levee slope. These pipes connected to the pump on river bank.

WS view: two exposed 12" tin pipes on levee slope.

WS view: two exposed tin pipes joined together and connected to 14-inch steel pipe on levee slope.

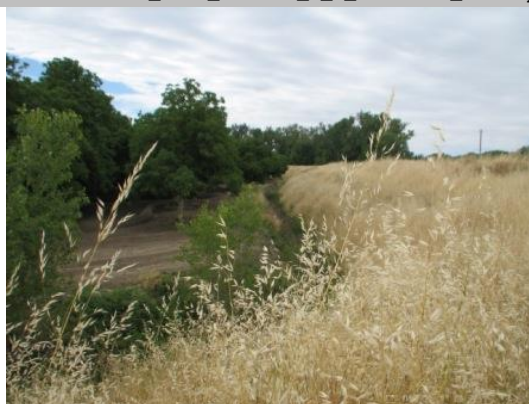
Photo 1 of 1 : SP_2017_RD1660_8_1_20170315_00001.jpg

LM Start	2.01	Rating **	U	Issue No.	1
LM End	2.34	Issue Type +	En	Location *	LS
Category	Earthen Levee			GPS Latitude/Longitude	
				Start	End
Item	Encroachments			39.037640 °	39.034416 °
				-121.828421 °	-121.825698 °
DWR ID	DWR_RD1660_01_s_2012_1				
Comment Code					
DT : Ditch					
Inspector Comment

View of a large ditch along the landside toe.

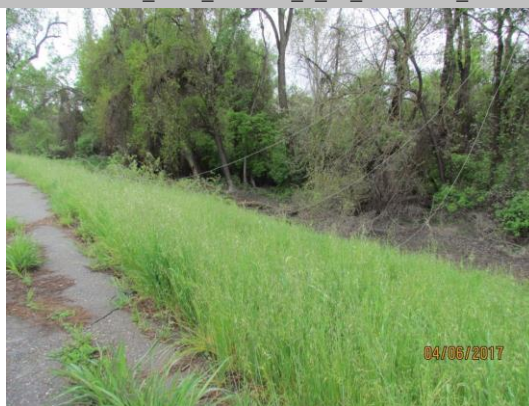
Photo 1 of 1 : SP_2017_RD1660_8_20_20170410_00018.jpg

View of the tree along the waterside slope and toe.

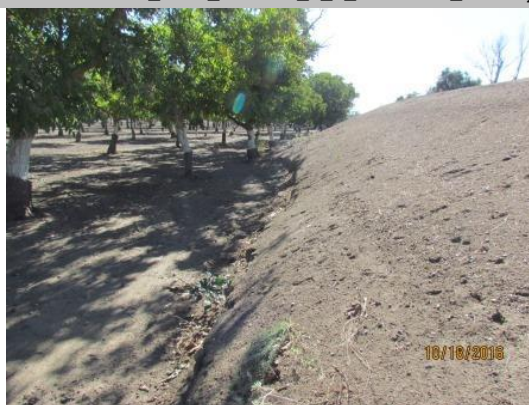
Photo 1 of 1 : SP_2017_RD1660_8_2_20170315_00002.jpg

LM Start	2.37	Rating **	M	Issue No.	2
LM End	2.37	Issue Type +	Ma	Location *	LS
Category	Earthen Levee			GPS Latitude/Longitude	
				Start	End
Item	Slope Stability			39.034107 °	39.034107 °
				-121.825152 °	-121.825152 °
DWR ID	DWR_RD1660_01_s_2012_2				
Comment Code					
S1 : Repair slope instability.					
Inspector Comment

View of the toe cut by the farmer on the landside.

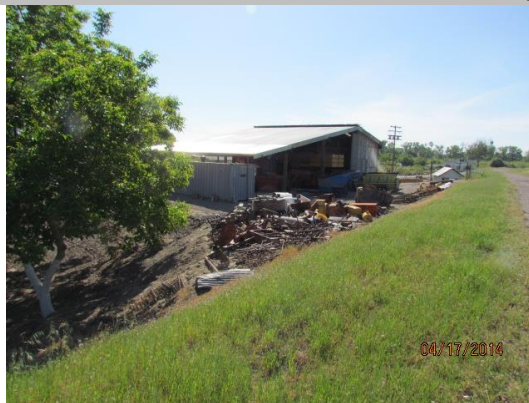
Photo 1 of 1 : SP_2017_RD1660_8_3_20170315_00003.jpg

View of equipment along the landside slope.

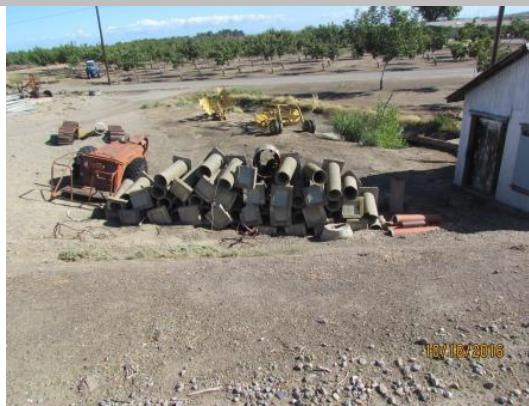
Photo 1 of 1 : SP_2017_RD1660_8_18_20170315_00007.jpg

LM Start	2.61	Rating **	M	Issue No.	18
LM End	2.61	Issue Type +	En	Location *	LS
Category	Earthen Levee			GPS Latitude/Longitude	
				Start	End
Item	Encroachments			39.031020 °	39.031020 °
				-121.823091 °	-121.823091 °
DWR ID	DWR_RD1660_01_f_2016_18				
Comment Code					
DE : Debris					
Inspector Comment					
Remove concrete pipes from the landside toe.

View of the concrete pipes within the levee easement.

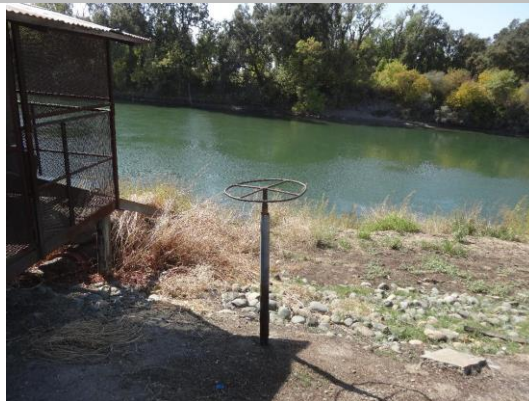
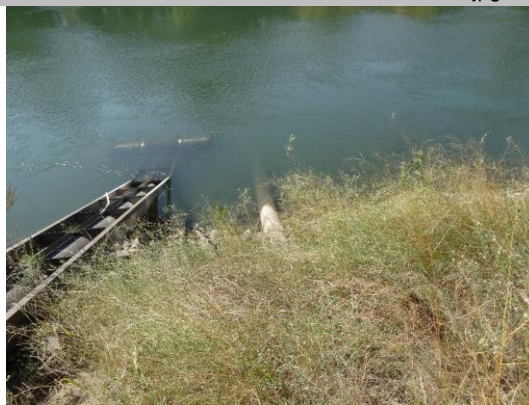
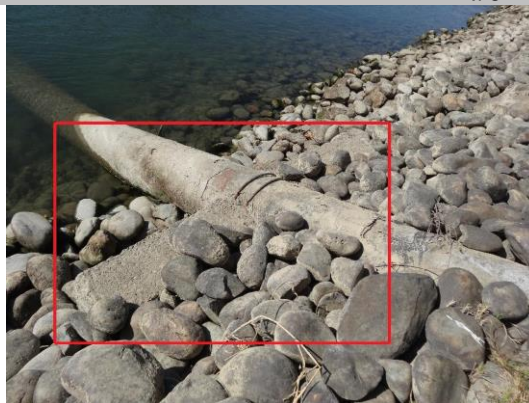
LM Start	2.62	Rating **	M	Issue No.	23
LM End	2.62	Issue Type +	En	Location *	LS
Category	Supplemental			GPS Latitude/Longitude	
				Start	End
Item	DWR UCIP Field Study			39.030935 °	39.030935 °
				-121.823022 °	-121.823022 °
DWR ID					
Comment Code					
Inspector Comment					
FS_ID:22632 DS_ID:22492 EP_NO: 10012 Repair Type: Non-Urgent Crossing Status: Found UCIP Comments: - abandoned pumphouse on landside toe. Needs confirmation from LMA or DWR Inspector about abandonment of pumphouse.- headwall on channel bank. FIELD_STRUCT_DESC: 24-inch steel pipe through levee, 24 feet below crown. Slide gate on waterward shoulder. Abandoned pumphouse at landward slope. (ABO No. 10012-Harris) FS Date: 10/10/2013

WS view: gate valve handle (center) on levee slope.

WS view: inlet steel pipe (right) immersed into channel water.

WS view: closer view of inlet steel pipe immersed into channel water.
Pipe was supported by concrete headwall.

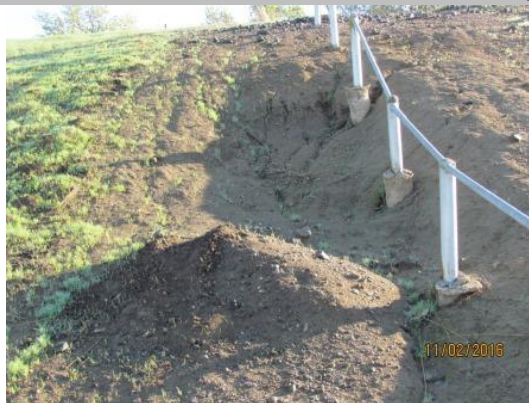
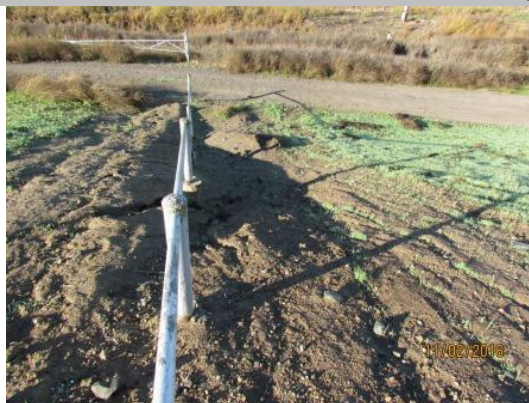
LM Start	0.00	Rating **	M	Issue No.	6
LM End	0.00	Issue Type +	Ma	Location *	LS
Category	Earthen Levee			GPS Latitude/Longitude	
				Start	End
Item	Slope Stability			39.032910 °	39.032910 °
				-121.743665 °	-121.743665 °
DWR ID	DWR_RD1660_02_f_2016_6				
Comment Code					
S1 : Repair slope instability.					
Inspector Comment

View of the slope instability looking from the landside toe.

Another view of the slope instability looking from the levee crown.

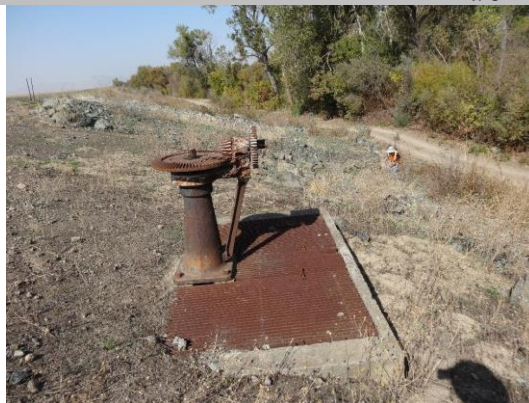
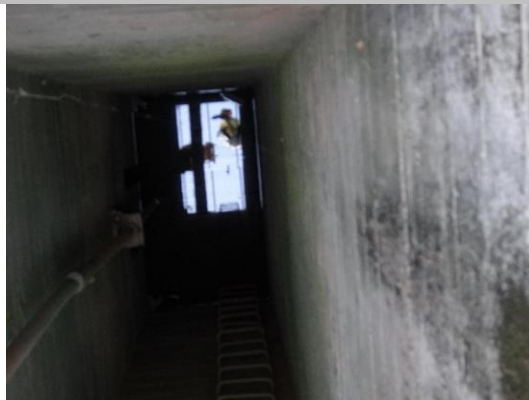
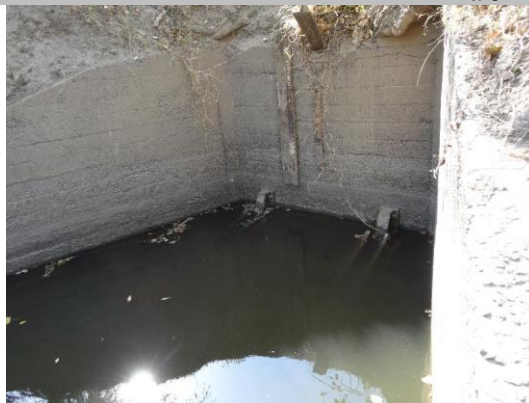
LM Start	0.02	Rating **	A/W	Issue No.	20
LM End	0.02	Issue Type +	Ma	Location *	LS
Category	Supplemental			GPS Latitude/Longitude	
				Start	End
Item	DWR UCIP LMA Responsibility			39.033214 °	39.033214 °
				-121.743541 °	-121.743541 °
DWR ID					
Comment Code					
Inspector Comment					
FS_ID:22663					
DS_ID:22495					
EP_NO: 10020					
Repair Type: No Action Needed					
Crossing Status: Found					
UCIP Comments: - pipe/opening not visible as it was submerged into water on both sides.- it seems that 36-inch concrete pipe through the levee. It needs confirmation from LMA/DWR Inspector.- USED bench mark on landside concrete vault.					
FIELD_STRUCT_DESC: 4 by 7 foot concrete outfall structure through levee, 34 feet below crown. Slide gate in 4 ft. by 8 ft. concrete riser on waterside slope. (App. 10020-Bandoni). O&M Manual SAC 133, August 1955.					
FS Date: 10/10/2013

WS view: 4 ft. by 8 ft. concrete box with slide gate on levee slope. USED bench mark on top of the box.

WS view: inside view of concrete box on levee slope. Slide gate in concrete box.

WS view: closer view of U shaped concrete headwall in bypass channel.
Pipe not visible.

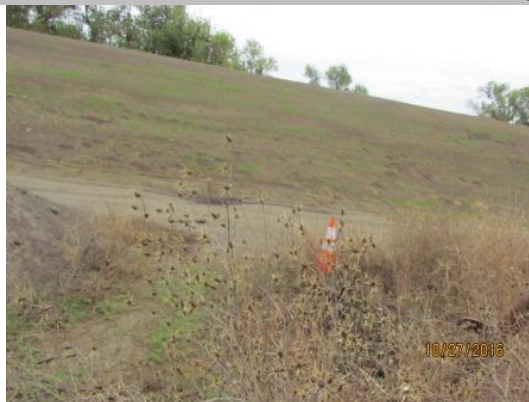
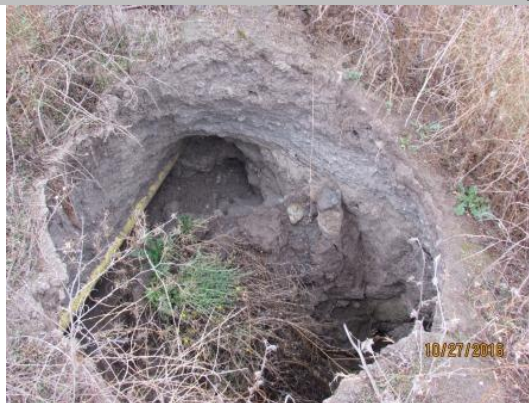
LM Start	0.04	Rating **	A/W	Issue No.	8
LM End	0.04	Issue Type +	Ma	Location *	LS
Category	Earthen Levee			GPS Latitude/Longitude	
				Start	End
Item	Slope Stability			39.033502 °	39.033502 °
				-121.743665 °	-121.743665 °
DWR ID	DWR_RD1660_02_f_2016_8				
Comment Code					
S1 : Repair slope instability.					
Inspector Comment					
Repair the site before flood season.

View of the levee from the landside toe. Beaver hole is where the reflective traffic cone is.

View of a beaver hole along the toe road outside of the levee easement.

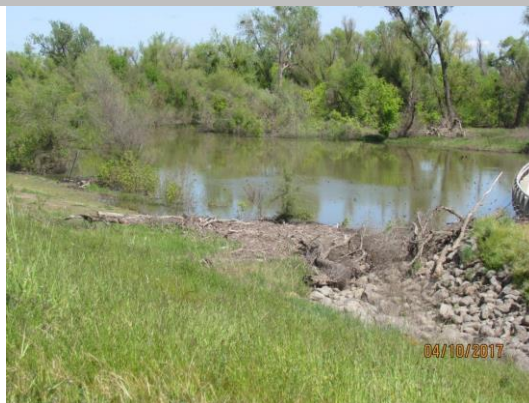
Photo 1 of 1 : SP_2017_RD1660_9_18_20170410_00016.jpg

LM Start	2.82	Rating **	M	Issue No.	18
LM End	2.82	Issue Type +	En	Location *	WS
Category	Earthen Levee			GPS Latitude/Longitude	
				Start	End
Item	Encroachments			39.071853 °	39.071853 °
				-121.759655 °	-121.759655 °
DWR ID	DWR_RD1660_02_s_2017_18				
Comment Code					
DE : Debris					
Inspector Comment					
Remove the debris from the waterside toe next to the bridge.

View of the debris along the waterside toe next to the bridge.

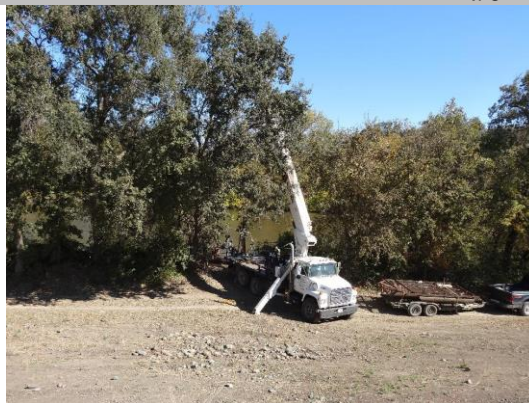
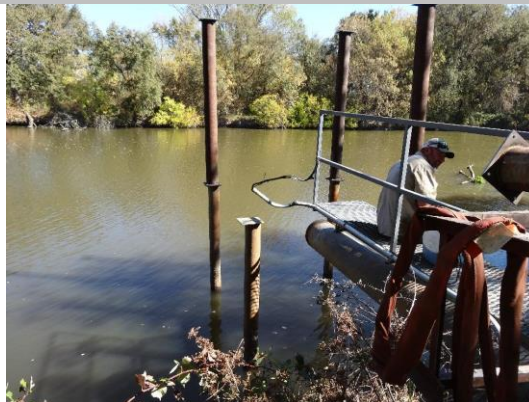
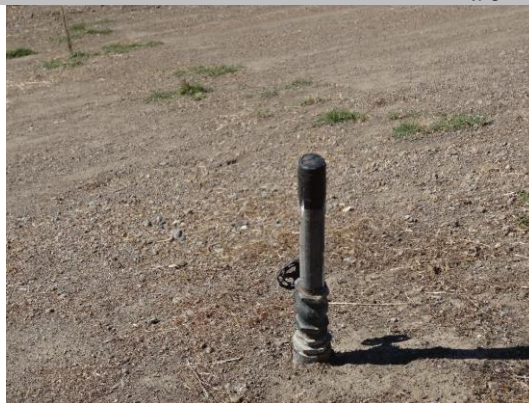
LM Start	5.10	Rating **	M	Issue No.	21
LM End	5.10	Issue Type +	En	Location *	WS
Category	Supplemental			GPS Latitude/Longitude	
				Start	End
Item	DWR UCIP Field Study			39.102512 °	39.102512 °
				-121.774960 °	-121.774960 °
DWR ID					
Comment Code					
Inspector Comment					
FS_ID:22705 DS_ID:22499 EP_NO: N/A Repair Type: Non-Urgent Crossing Status: Found UCIP Comments: Pressure relief valve on landside levee slope.Pump platform under construction for upgrade (raising platform)Look for new upgrade/revision permit. FIELD_STRUCT_DESC: 18-inch steel pipe through the levee, 5.8 feet below crown. Pump in channel. Gate valve on the landward berm. Discharges into 4-foot by 4 foot concrete box on the landward berm. 2-inch electric conduit through the levee, 3.0 feet below the crown. (Permit No. 4215, 1963) FS Date: 10/15/2013

WS view: pump platform under construction.

WS view: pump platform under construction. 18" steel pipe and 2" electric conduit under steel platform.

LS view: pressure relief valve on levee slope.

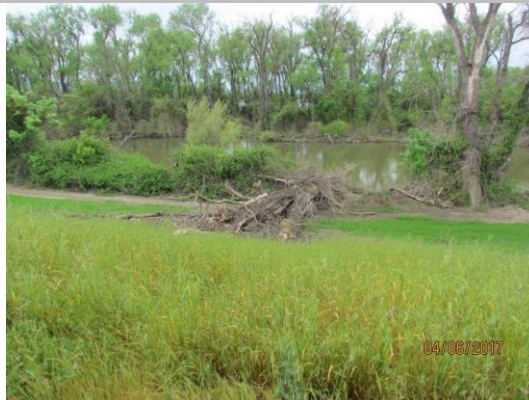
Photo 1 of 1 : SP_2017_RD1660_9_13_20170410_00015.jpg

LM Start	6.49	Rating **	M	Issue No.	13
LM End	6.49	Issue Type +	En	Location *	WS
Category	Earthen Levee			GPS Latitude/Longitude	
				Start	End
Item	Encroachments			39.115142 °	39.115142 °
				-121.794823 °	-121.794823 °
DWR ID	DWR_RD1660_02_s_2017_13				
Comment Code					
TR : Tree or limb					
Inspector Comment					
Remove the tree from the waterside slope and toe.

View of the tree along the waterside slope and toe.

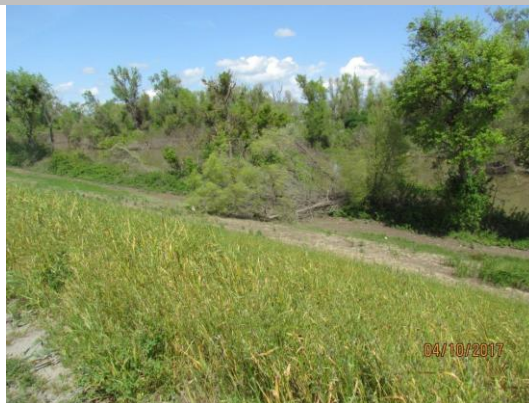
Photo 1 of 1 : SP_2017_RD1660_9_19_20170410_00017.jpg

View of the tree along the waterside toe.

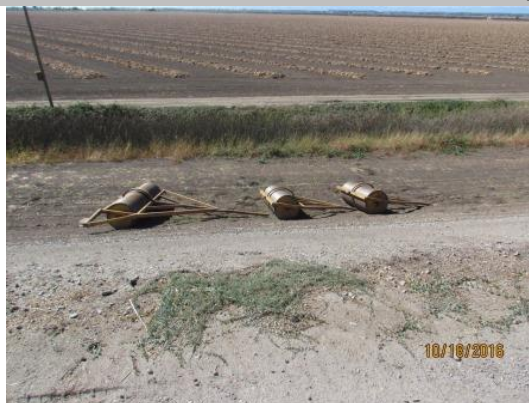
Photo 1 of 1 : SP_2017_RD1660_9_5_20170315_00001.jpg

View of the ag equipment within the levee easement.

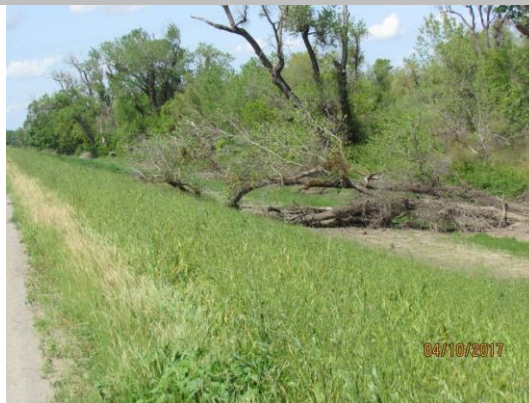
Photo 1 of 1 : SP_2017_RD1660_9_17_20170410_00018.jpg

LM Start	8.03	Rating **	M	Issue No.	17
LM End	8.03	Issue Type +	En	Location *	WS
Category	Earthen Levee		GPS Latitude/Longitude		
			Start	End	
Item	Encroachments		39.128130 °	39.128130 °	
			-121.818210 °	-121.818210 °	
DWR ID	DWR_RD1660_02_s_2017_17				
Comment Code					
TR : Tree or limb					
Inspector Comment					
Remove the tree from the waterside slope and toe.

View of the tree along the waterside slope and toe.

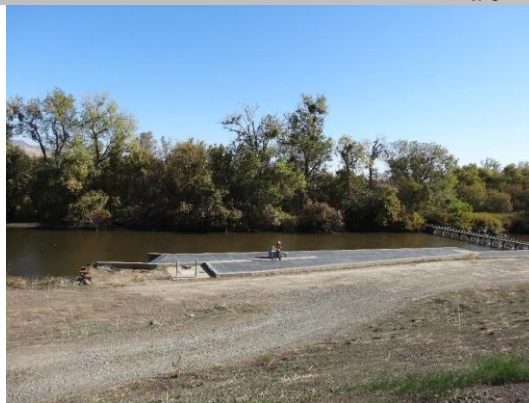
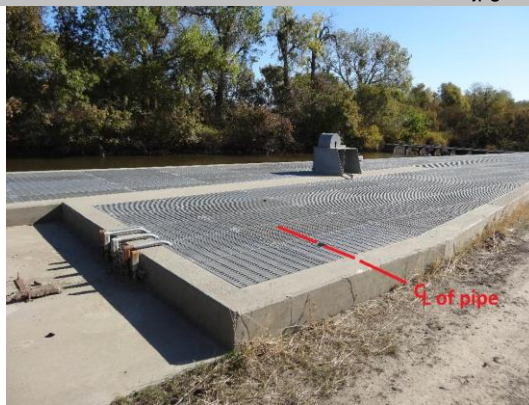
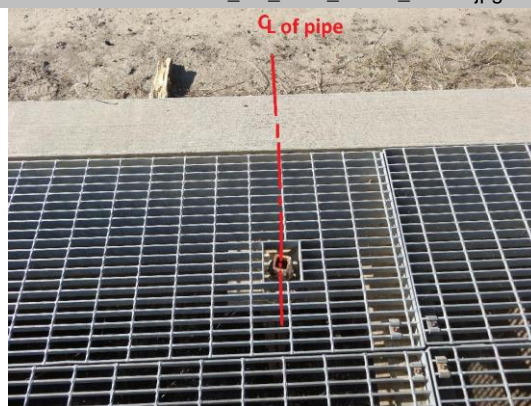
LM Start	9.07	Rating **	A/W	Issue No.	22
LM End	9.07	Issue Type +	Ma	Location *	WS
Category	Supplemental			GPS Latitude/Longitude	
				Start	End
Item	DWR UCIP LMA Responsibility			39.136861 °	39.136861 °
				-121.833974 °	-121.833974 °
DWR ID					
Comment Code					
Inspector Comment					
FS_ID:22708					
DS_ID:22505					
EP_NO: N/A					
Repair Type: No Action Needed					
Crossing Status: Found					
UCIP Comments: - inlet structure 160 ft off the levee center on landside drainage ditch.					
FIELD_STRUCT_DESC: 48-inch steel pipe through the levee, 29.0 feet below the crown. Slide gate and concrete bulkhead on channel bank.					
Staff gage on the waterward berm. ABO# 10021. O&M Manual SAC 133, August 1955.					
FS Date: 10/15/2013

WS view: overview of concrete box on channel bank. It looks like a fish ladder. Pipe discharges into this box.

WS view: concrete box on channel bank. Pipe end with slide gate. Pipe discharges into this box.

WS view: concrete box on channel bank. Pipe discharges into this box.
A slide gate inside this box.
